Fire Protection**Case 1449 - 16/06/2023 - BMC - Fire Services Inspection & Testing - May 2023**

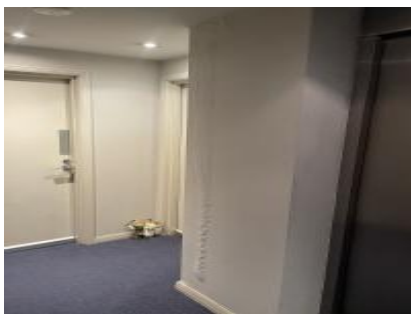
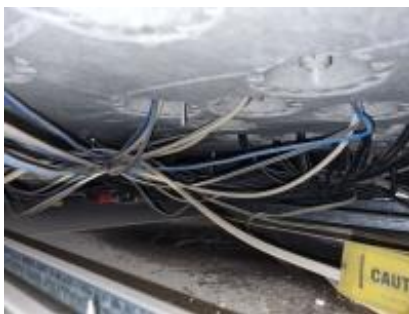
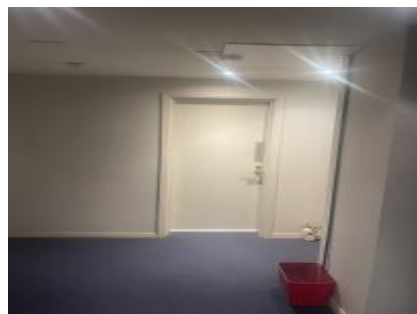
Case 1391 - 24/03/2023 - Ceiling Leak - Level 3 Lift Lobby

Routine inspection identified a leak coming from the ceiling of the level 3 lift lobby. Unplugged Plumbing was engaged to investigate.

The leak is located near the bathroom of Apartment 401 so Unplugged Plumbing tested the shower and bathroom fittings. No issue identified. Inspection inside the level 3 ceiling located water dripping from a conduit

inside the slab. The conduits lead back to each apartment containing wiring for intercoms etc. Further investigation required to identify which apartment the leaking conduit leads back to. A tray was installed under the leak and plumbed back to a bucket to minimise further damage and allow easy monitoring.

Once the leak in apartment 405 was rectified (Case 1372) the leaking stopped. Building management to monitor for a week.

Plumbing works complete. Invoice 7209 Received for \$352.00 and approved for payment.

FreshLook was engaged to repair the water damaged level 3 lobby ceiling and wall.

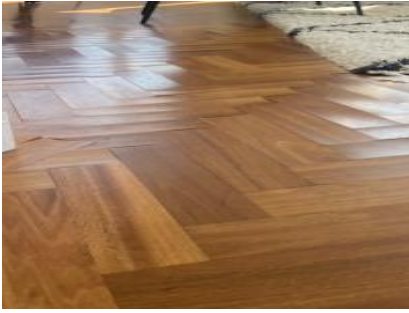
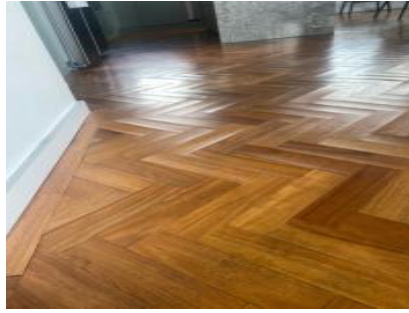
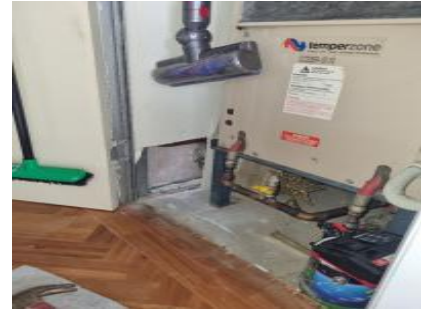
Case 1372 - 10/03/2023 - Leak Investigation - Apt 405

Apartment 405 has reported water damage on the timber flooring adjacent to the bathtub and air conditioning cupboard. Unplugged Plumbing was engaged to investigate the cause and found the air conditioning unit was leaking. Lot owner advised to engage the services of a HVAC contractor.

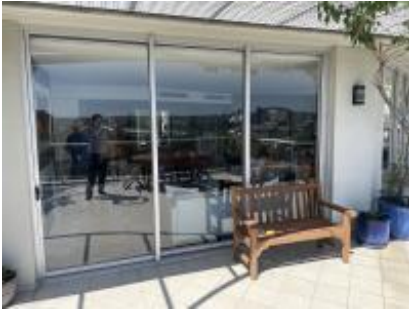
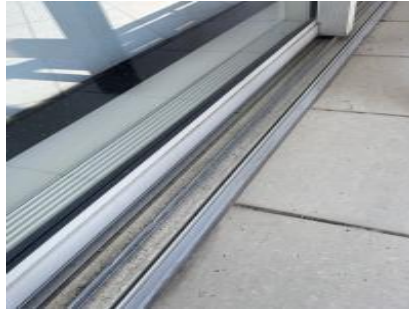
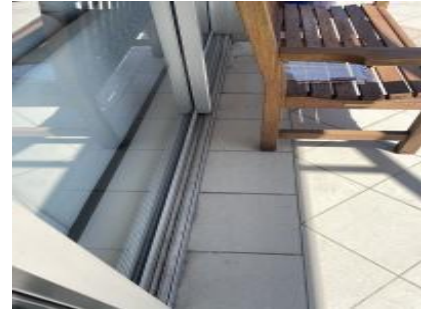
Case 1375 - 14/03/2023 - Balcony Sliding Door Repairs - Apt 601 Loungeroom

Apartment 601 is having issues operating the 3-piece glass aluminum sliding doors leading from the loungeroom area to the balcony. Lock & Roll have investigated and reported that the bottom rail is warped and must be replaced for the door to operate correctly.

Dormakaba was engaged for a 2nd opinion and confirmed that as it is a whole sliding door frame and repairs are not possible. Recommendation to engage an aluminum fabrication company for replacement.
