BUILDING MANAGER'S REPORT

Marquis (SP67851)

01 Aug 2023

Reporting period: 01 Jul 2023 to 01 Aug 2023

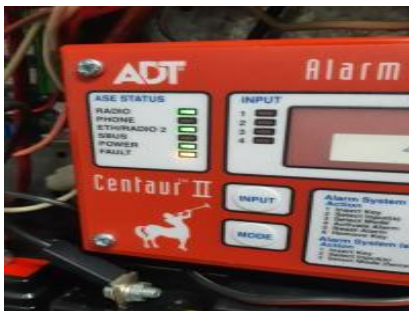
Newsound Fire have reported a fault on the ASE. ADT was engaged to investigate and advised the unit is due for a 4G upgrade. ADT have engaged Talking Point to supply and install the upgraded unit on 18.7.23 from 8am. Building access was pre-arranged.

Upgrade complete.

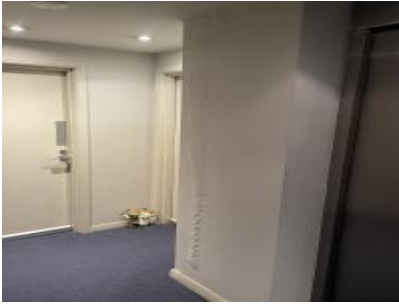
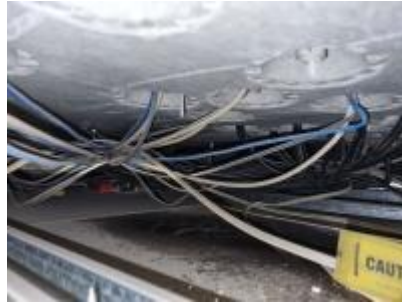
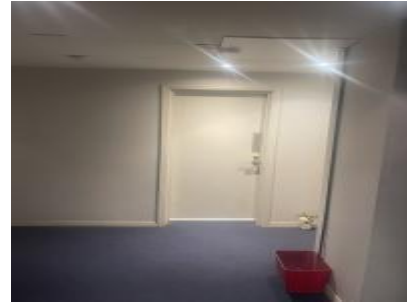
Routine inspection identified a leak coming from the ceiling of the level 3 lift lobby. Unplugged Plumbing was engaged to investigate.

The leak is located near the bathroom of Apartment 401 so Unplugged Plumbing tested the shower and bathroom fittings. No issue identified. Inspection inside the level 3 ceiling located water dripping from a conduit inside the slab. The conduits lead back to each apartment containing wiring for intercoms etc. Further investigation required to identify which apartment the leaking conduit leads back to. A tray was installed under the leak and plumbed back to a bucket to minimise further damage and allow easy monitoring.

Once the leak in apartment 405 was rectified (Case 1372) the leaking stopped. Building management to monitor for a week.

FreshLook was engaged to repair the water damaged level 3 lobby ceiling and wall.

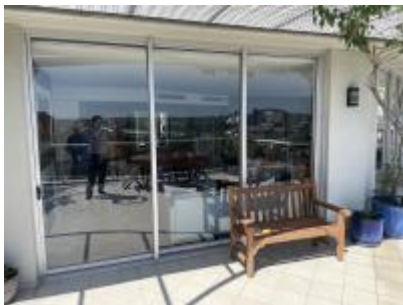
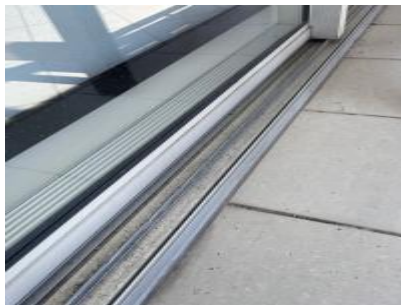
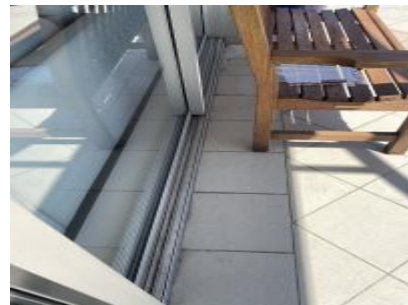
Apartment 601 is having issues operating the 3-piece glass aluminium sliding doors leading from the loungeroom area to the balcony. Lock & Roll have investigated and reported that the bottom rail is warped and must be replaced for the door to operate correctly.

Dormakaba was engaged for a 2nd opinion and confirmed that as it is a whole sliding door frame and repairs are not possible. Recommendation to engage an aluminium fabrication company for replacement.
