## ACP LABORATORY RESULTS

SP 67851: 200 WILLIAM STREET, WOOLLOOMOOLOO NSW 2011

JULY 13, 2021

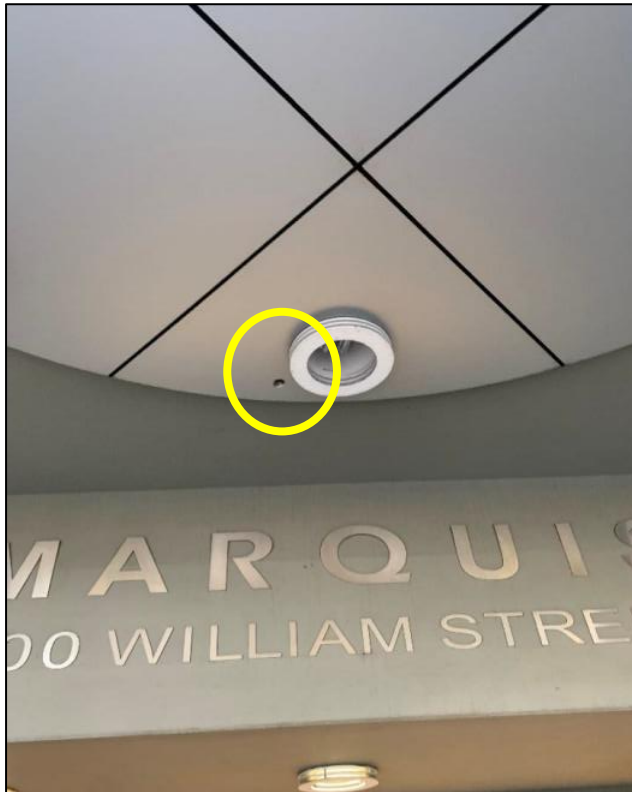
Samples of the external cladding were taken on the 23<sup>rd</sup> of June 2021, to identify the type of cladding which has been installed to the building façade. The samples of the external cladding mentioned above were taken from the ground level awning at the western elevation of the building and the south-western corner of Level 1 of the building, as shown in **Photograph 1** and **Photograph 3**.

**Photograph 1 – Location of sample (Ground Level Awning on the Western Elevation) taken for laboratory testing**

| Sample # | Location | % of polyethylene | ICA Classification |
|---|---|---|---|
| Sample 1 | Western Elevation (Ground Level Awning) | 29% | B |

The laboratory results have identified the Aluminium Composite Panels to have a polyethylene core slightly less than 30% by mass. However, based on the high combustibility and unknown manufacturer of the installed product, it is recommended that all ACP cladding to the façade be replaced with a suitable non-combustible material.

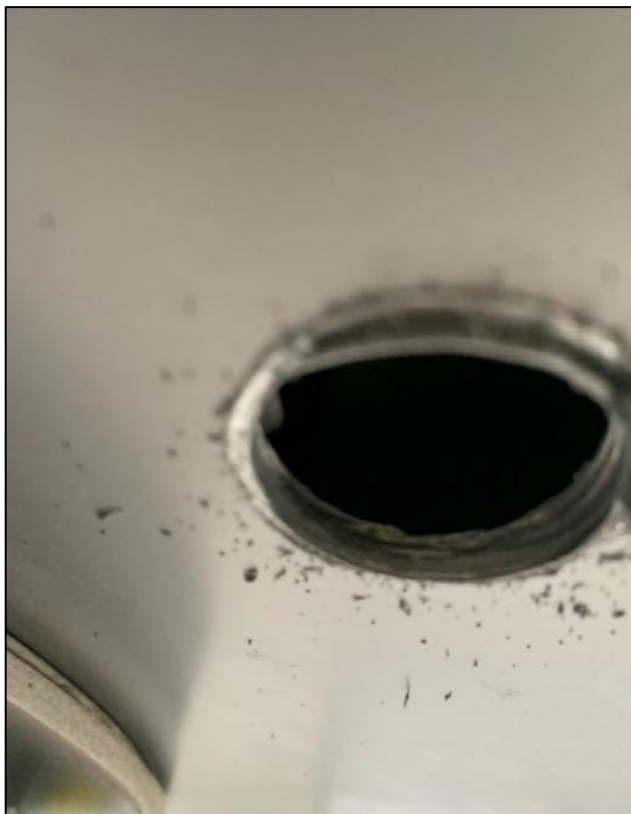
Subsequent laboratory testing was approved to identify the unknown core material found during the intrusive investigation. Samples of the ACP cladding were removed from the ground level awning at the western elevation of the building and the south-western corner of Level 1 of the building, as shown in **Photograph 2** and **Photograph 4**.

**Photograph 2 – Sample of ACP cladding taken from the Awning on the Western Elevation**

The core #1 consisted of 68.1% aluminium trihydrate, 3.3% other mineral matter and approximately 29% polyethylene polymer.

**The cladding sample #1 is classified as ICA Category B.**

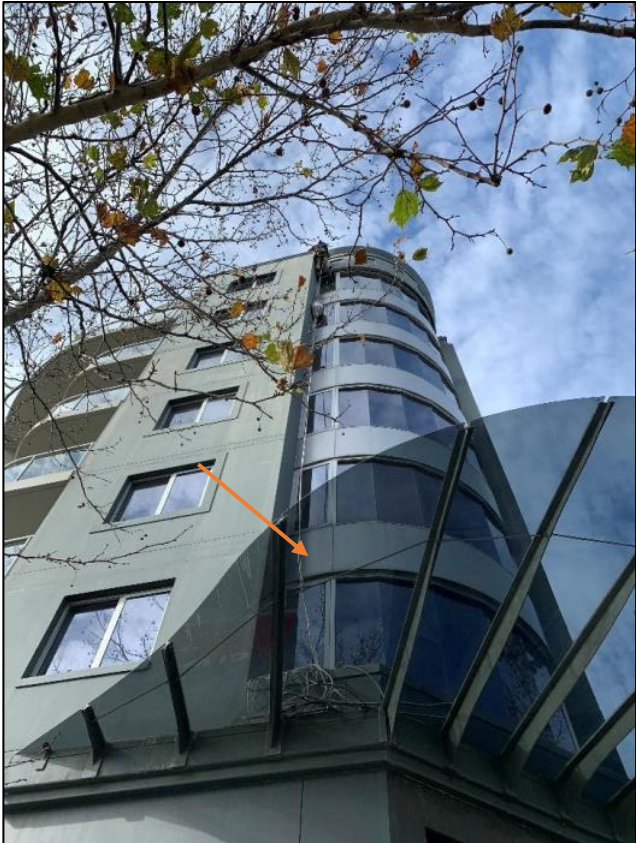
**Photograph 3 – Location of sample (SW corner of the building) taken for laboratory testing**

| Sample # | Location | % of polyethylene | ICA Classification |
|---|---|---|---|
| Sample 2 | South-western Corner of the Building | 28% | B |

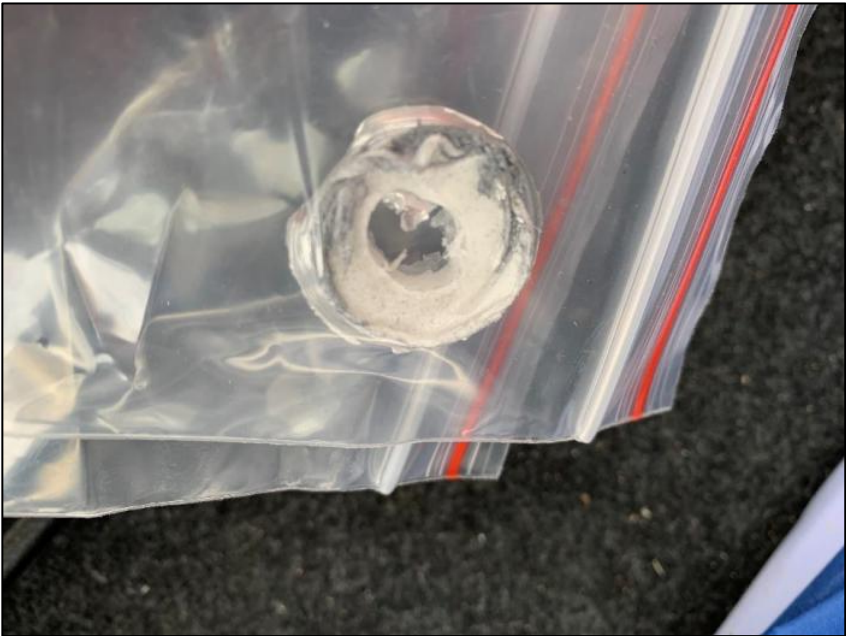
**Photograph 4 – Sample of ACP cladding taken from the SW corner of the facade**

The core #2 consisted of 67.6% aluminium trihydrate, 4.5% other mineral matter and approximately 28% polyethylene polymer.

**The cladding sample #2 is classified as ICA Category B.**

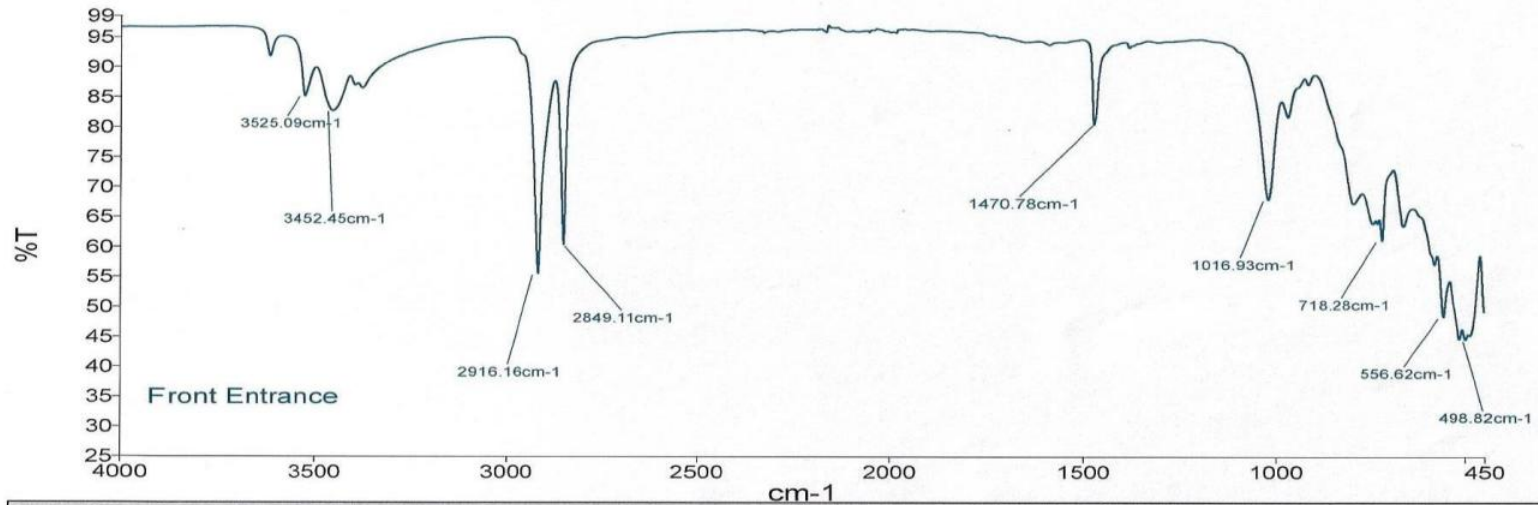
Front Entrance

The sample was found to have characteristics which are consistent with low density polyethylene. The results are displayed in Annexure A.
