## ACP LABORATORY RESULTS

SP 67851: 200 WILLIAM STREET, WOOLLOOMOOLOO NSW 2011

JULY 13, 2021

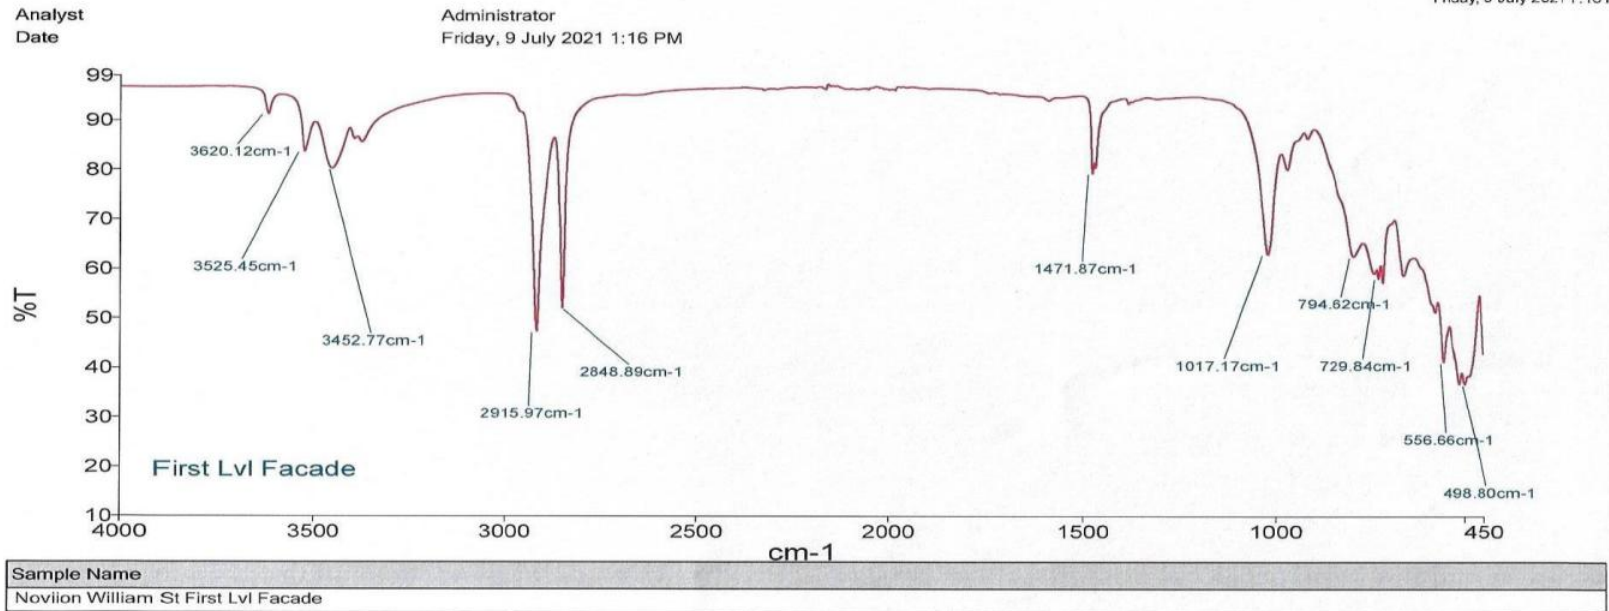
PerkinElmer Spectrum IR Version 10.6.1  
Friday, 9 July 2021 1:16 PM

The sample was found to have characteristics which are consistent with low density polyethylene. The results are displayed in Annexure A.
